# **Ministry of Education**

# **Catalogue of Standard School Building Types**

# Canterbury Block

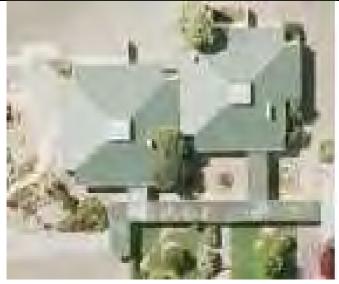
Floor plan (Shirley Primary School)

Building descrip	otion	Variants within standard design
Roof	Pyramidal roof (with central roof lantern)	Unknown
Walls and	Timber framed with fibre cement sheet	Unknown
cladding	Timber framed with fibre cement sheet	OTIKITOWIT
Floor and	Concrete slab on grade with perimeter edge	Unknown
foundations	thickenings	
Constructed	From 1977 to 1979	(approximate date range only)
Key identifying	Internal timber trusses, truncated pyramidal	Unknown
features	roof. Three classrooms around central	
	resource room and open out onto small	
	verandas

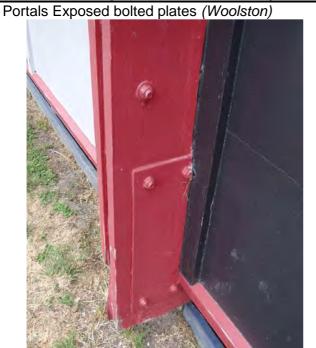
Portals Exposed Gang nail plates (Woolston)

Building description		Variants within standard design
Roof	Corrugated metal roofing. Gang nail timber portal frames at 3m or 2.9m centres with metal cappings	Unknown
Walls and cladding	Walls built in panels between portals. Asbestos Fibre cement	Varying panel layouts with different window units.
Floor and foundations	Suspended timber floor with piles under portal frames and joists spanning between portals	Older blocks may have corner concrete foundations
Constructed	From 1969 to 1985	(approximate date range only)
Key identifying features	External Portals can be seen on roof and along walls, Cover battens internally at portals to allow separation. Portals frames and nail plates exposed along outside walls. Can found as single or double classrooms with toilets in middle. Other layouts may include longer blocks of up to 10 bays with large open classrooms for technology rooms etc.	Some portals have bolted connections Older CEBUS classrooms are 8m wide including portals and 3m bays. Newer classrooms identical but 7.5m wide and 2.9m between portals

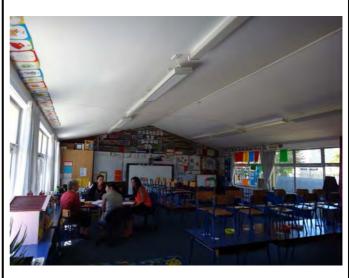
Inside view of ceiling (Shirley Primary Block)

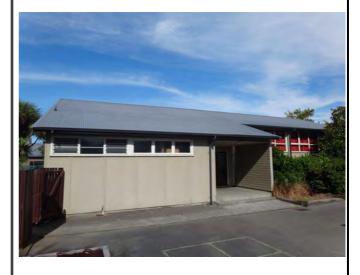
Side view (Wairakei Rd)

Building descri	ption	Variants within standard design
Roof	Ridged centrally along of the building. Clad in lightweight corrugated steel roofing	Unknown
Walls and cladding	Weather Board and Asbestos Fibre Cement. (Wairakei)	Concrete block veneer (Linwood North Primary School) Clay brick veneer (Hammersley Park)
Floor and foundations	Suspended timber floor and concrete perimeter foundations and concrete floor toilets.	Unknown
Constructed	Age range unknown	
Key identifying features	Unknown	Unknown

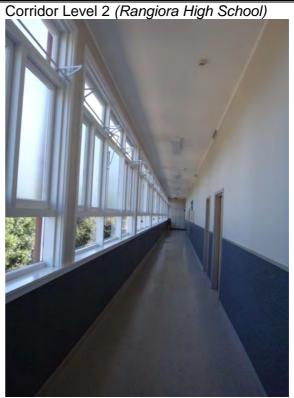
Corridor Level 1 (Rangiora High School)

Building descri	ption	Variants within standard design
Roof	Ridged centrally along the building. Clad in lightweight corrugated steel roofing	Unknown
Walls and cladding	Vertical weatherboard, concrete, clay brick and Asbestos Fibre Cement.	Unknown
Floor and foundations	Suspended timber floor level 1 with concrete perimeter foundations and concrete floor to toilets. Concrete upper floor (to be confirmed)	Unknown
Constructed	Age range unknown	
Key identifying features	Straight shape with stair wells at each end of Block.	Unknown
